Periodic Dam Safety Inspection Report

Beitey Lake Dam
Stevens County, Washington

June 2001
Pub. No. 01-11-009

Water Resources Program
Report 01-11-009

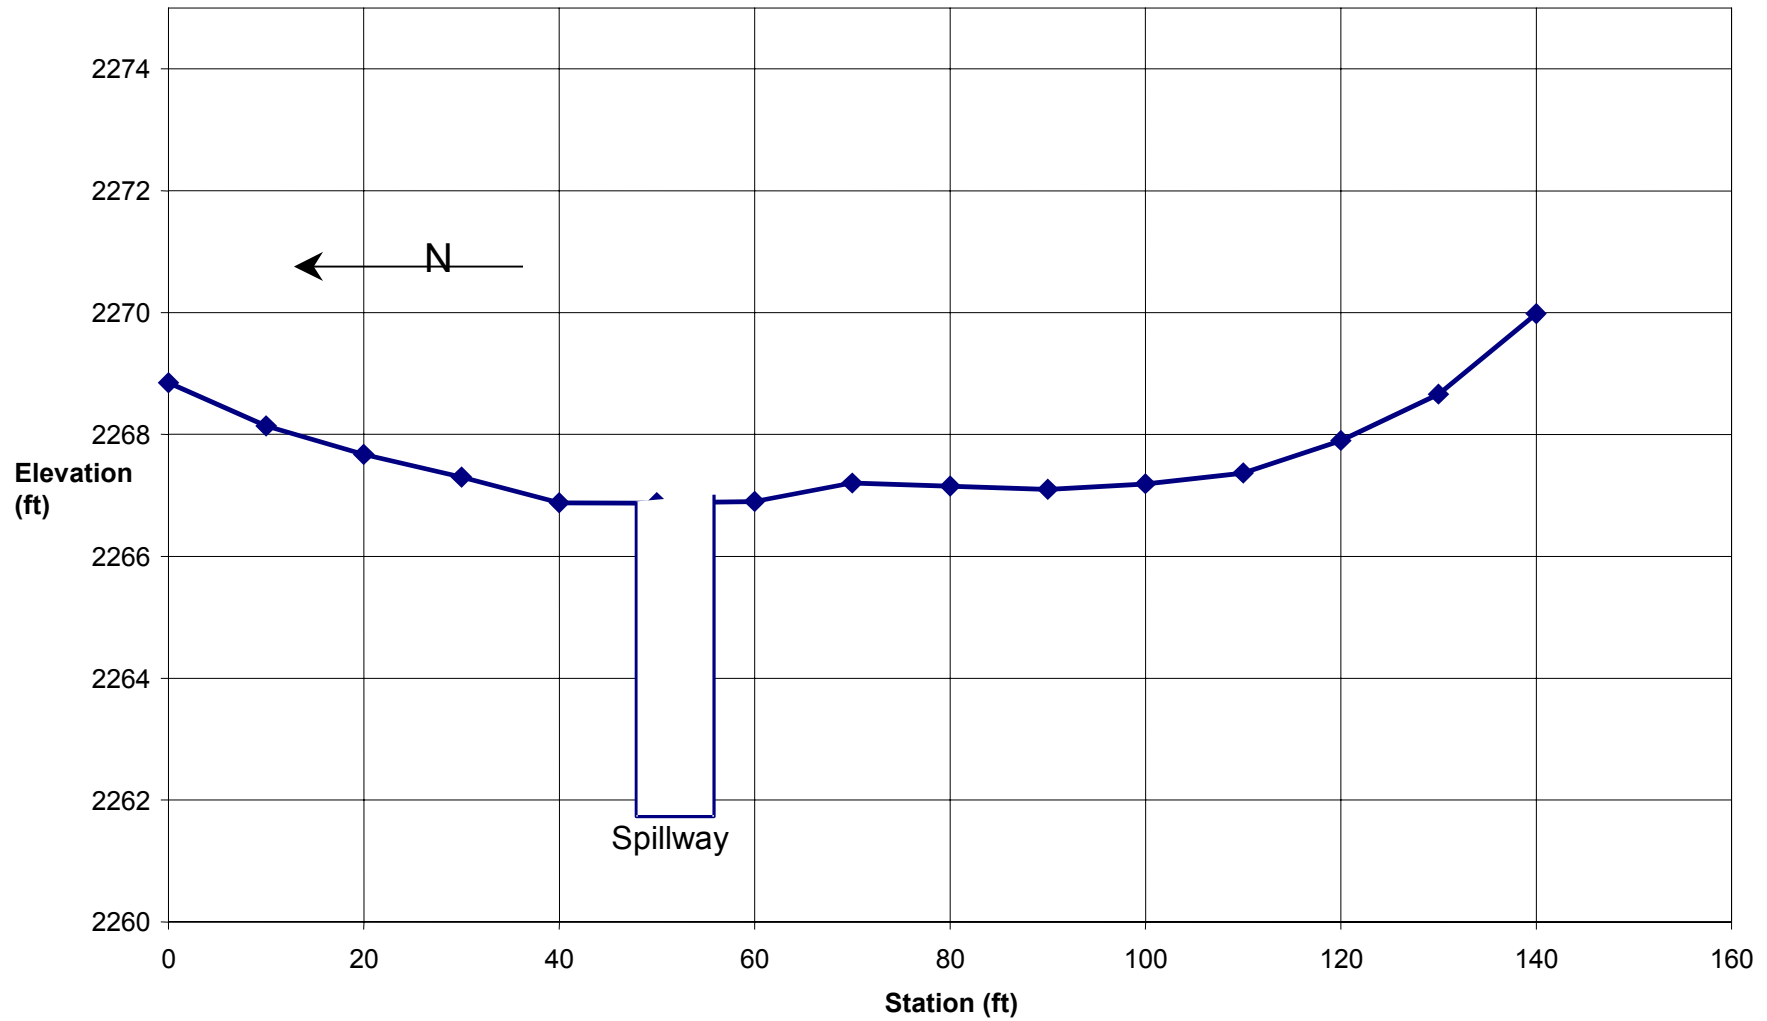
Figure 3 - Beitey Lake Dam Crest Profile

Beitey Lake Dam is an earthfill embankment with a concrete core wall and downstream rock facing. The dam has a height of 15 feet, a crest width of 12 feet, and a crest length of 100 feet. A survey of the dam during our inspection revealed the crest elevation varies from 2266.9 feet near the spillway, to 2268 feet at the right abutment. (Figure 3). According to Mr. Beitey, the concrete core wall was reinforced with steel, and the top of the wall is about 2 feet below the dam crest level. The core wall was not founded in bedrock, but instead was founded in "hardpan" 3 feet below the streambed. The upstream

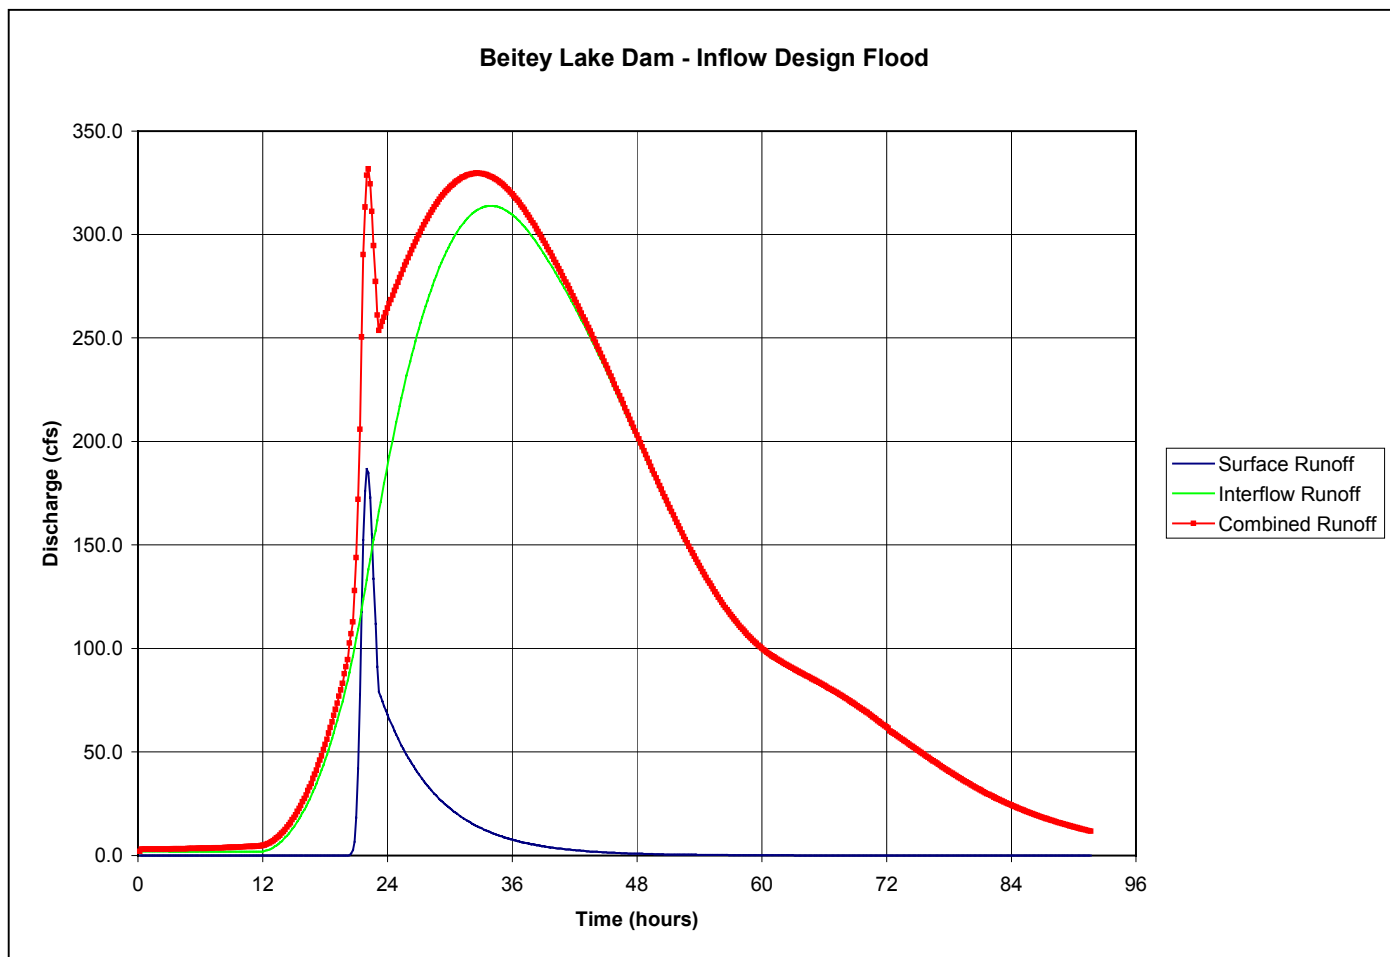
Figure 5 – Design Flood Hydrograph

The above parameters were used in the HEC-1 model to determine the Inflow Design Flood (IDF). The total inflow hydrograph (surface, interflow, and rainfall on the lake) is shown in Figure 5. The computed Step 4 IDF had a peak inflow of about 330 cubic feet per second (cfs), with a total runoff volume of 940 acre-feet (5.7 inches) on the watershed.

The initial reservoir elevation was set at 2263 feet, which is at the principal spillway stoplog elevation. This reservoir level is considered the normal maximum operating level. The flood routing revealed that the IDF exceeded the capacity of the existing spillway, and would overtop the dam by one foot for several hours. Such a depth of overtopping would likely result in an erosive failure of the downstream rock fill, removing support for the concrete core wall. This in turn would probably result in collapse of the core wall and failure of the dam. Based on the foregoing, with the present dam and spillway configuration, Beitey Lake Dam cannot safely accommodate the IDF. In fact, the analysis showed that the facility can presently only handle about 50% of the design flood.

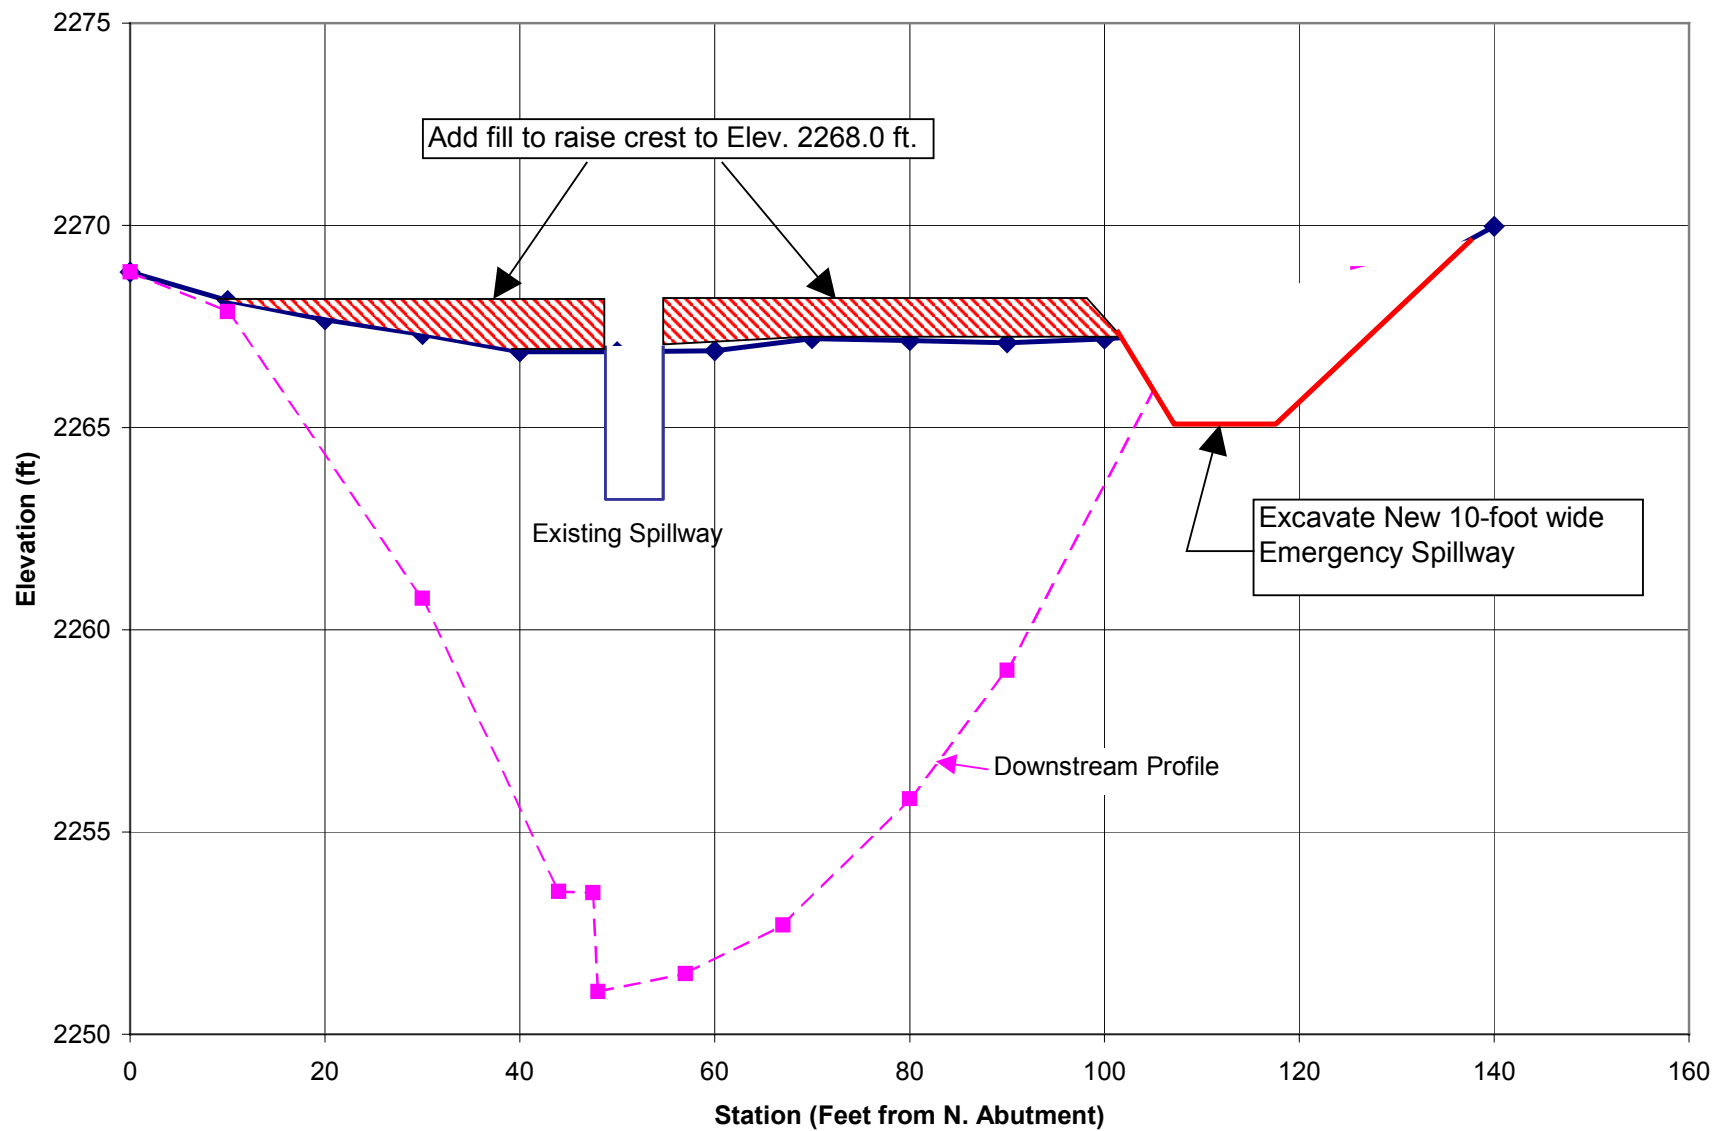
Beitey Lake Dam - Crest Profile Looking Upstream
Figure 6 - Repair Option 1: Construct 10 Foot Wide Emergency Spillway

Option 1: 10 foot wide emergency spillway – This option would involve excavating a 10-foot wide emergency spillway around the left (south) abutment of the dam with a floor elevation of 2265 feet, and adding one foot of fill to the dam crest to raise the elevation to 2268.0 feet. Figure 6 provides a conceptual drawing of this repair scheme. With these modifications, the dam can handle the IDF with 0.6 feet of freeboard below the crest elevation. The advantage of this scheme is that it would be relatively easy and inexpensive to construct. The disadvantage is that it would require extensive regrading of the road on the left abutment to maintain access across the dam for logging trucks. Also, the concrete sidewalls of the spillway chute would have to be raised one foot.

1. **Construct 10 foot wide emergency spillway** – This option would involve excavating a 10-foot wide emergency spillway around the left (south) abutment of the dam, and adding one foot of fill to the dam crest to raise the elevation to 2268.0 feet. Figure 6 provides a conceptual drawing of this repair scheme.

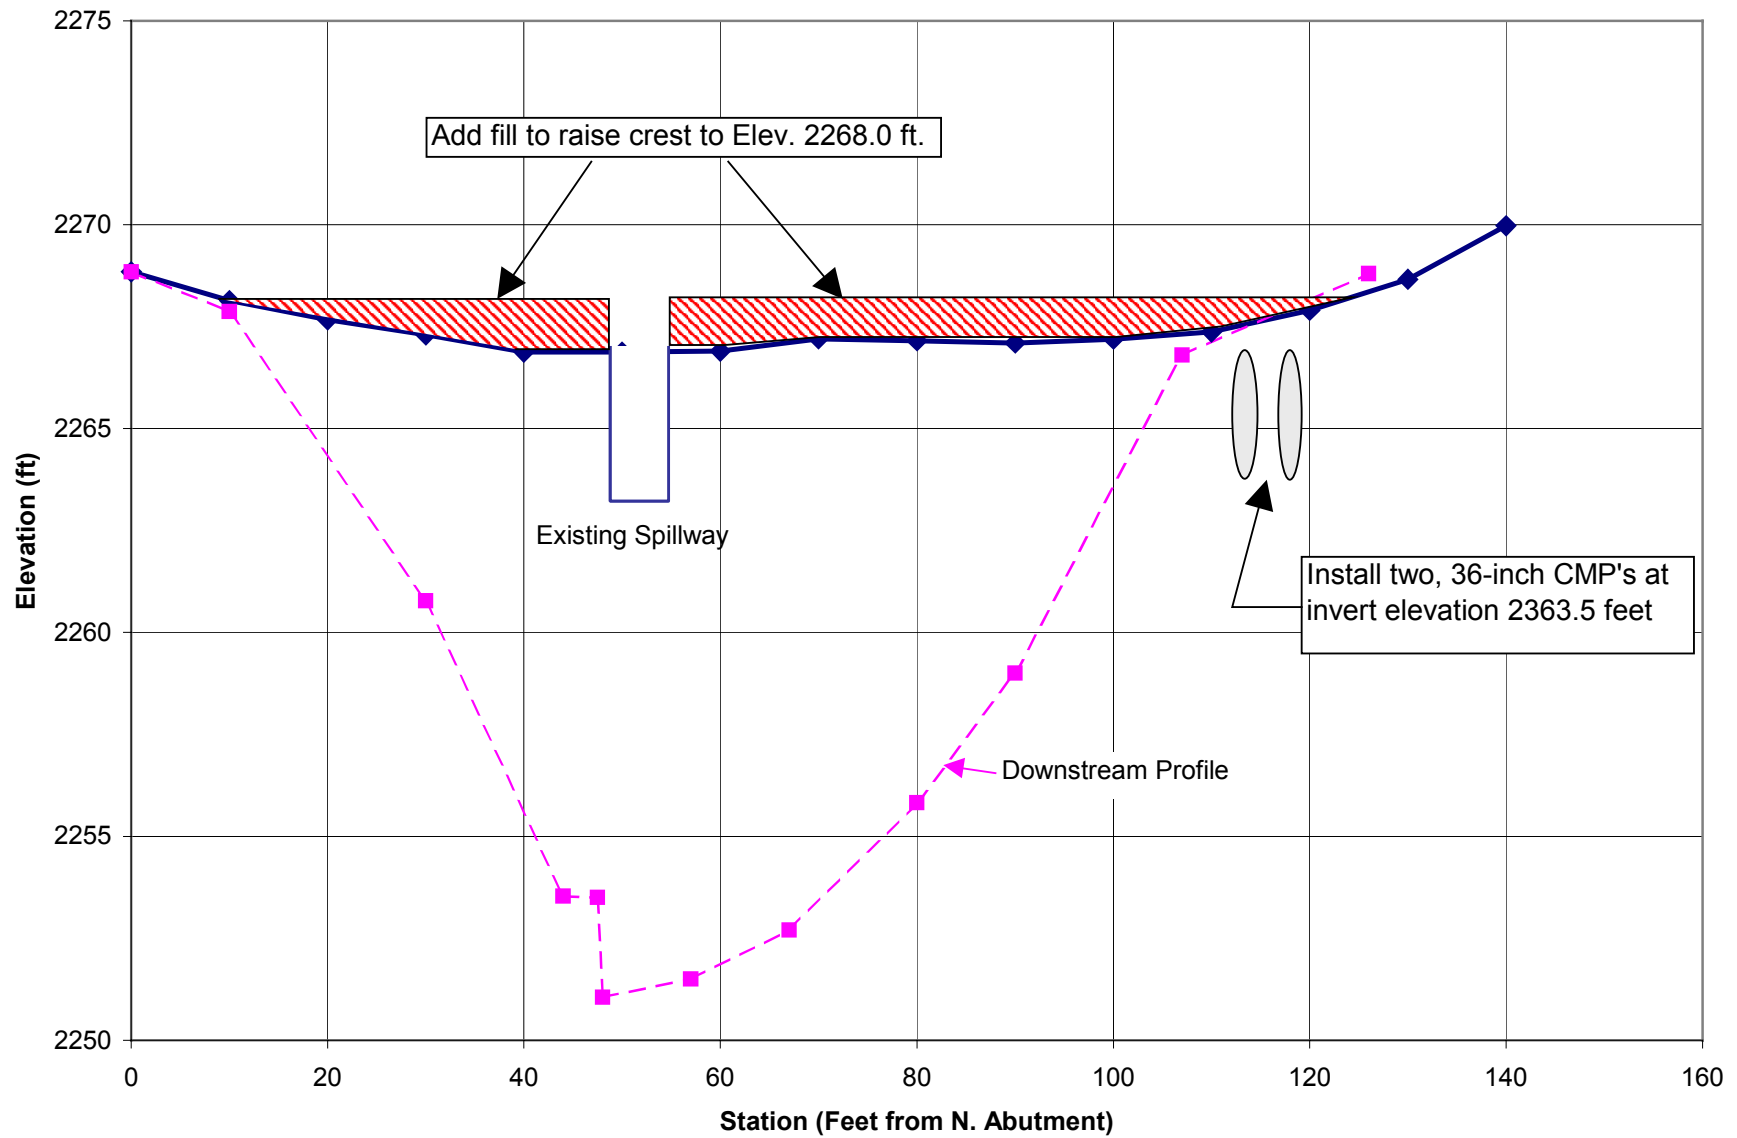
Beitey Lake Dam - Crest Profile Looking Upstream
Figure 7 - Repair Option 2: Install Twin 36-inch Pipes

Option 2: Install Two 36-inch Pipes on Left Abutment – This option would involve installing twin 36-inch diameter Corrugated Metal Pipes through the left abutment of the dam, with the invert elevation of the pipes at 2263.5 feet (Figure 7). The pipes would discharge into a channel on the downstream left abutment that would direct spillway flows away from the toe of the dam. Under this repair scheme, the dam could pass the flood with 0.5 feet of freeboard below the crest. The advantage of this scheme is that the dam crest and existing spillway walls would not have to be raised, and the road over the dam would not require regrading. The disadvantage would be the cost of purchasing and installing the conduits.

2. **Install Two 36-inch Pipes on Left Abutment** – This option would involve installing twin 36-inch diameter Corrugated Metal Pipes through the left abutment of the dam, with the invert elevation of the pipes at 2263.5 feet. The pipes would discharge into a channel on the downstream abutment that would direct spillway flows away from the toe of the dam. Figure 7 provides a conceptual drawing of this repair scheme.

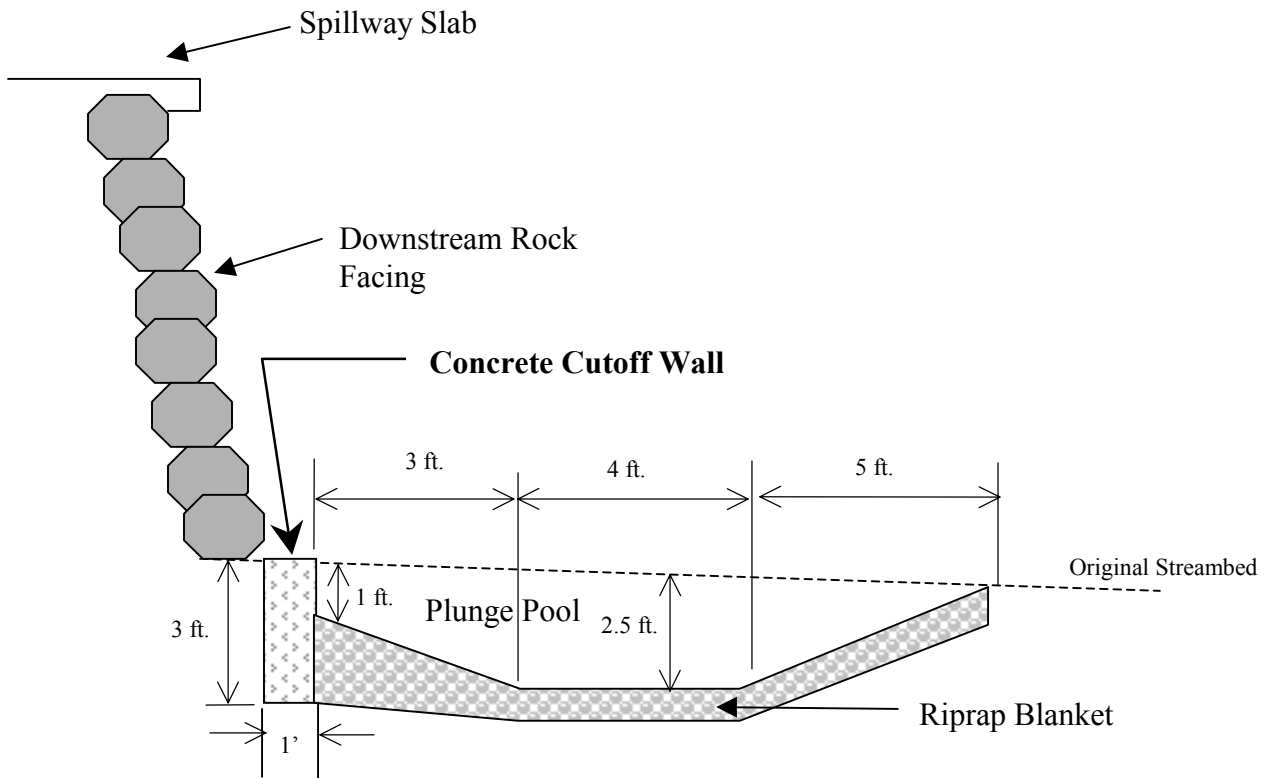
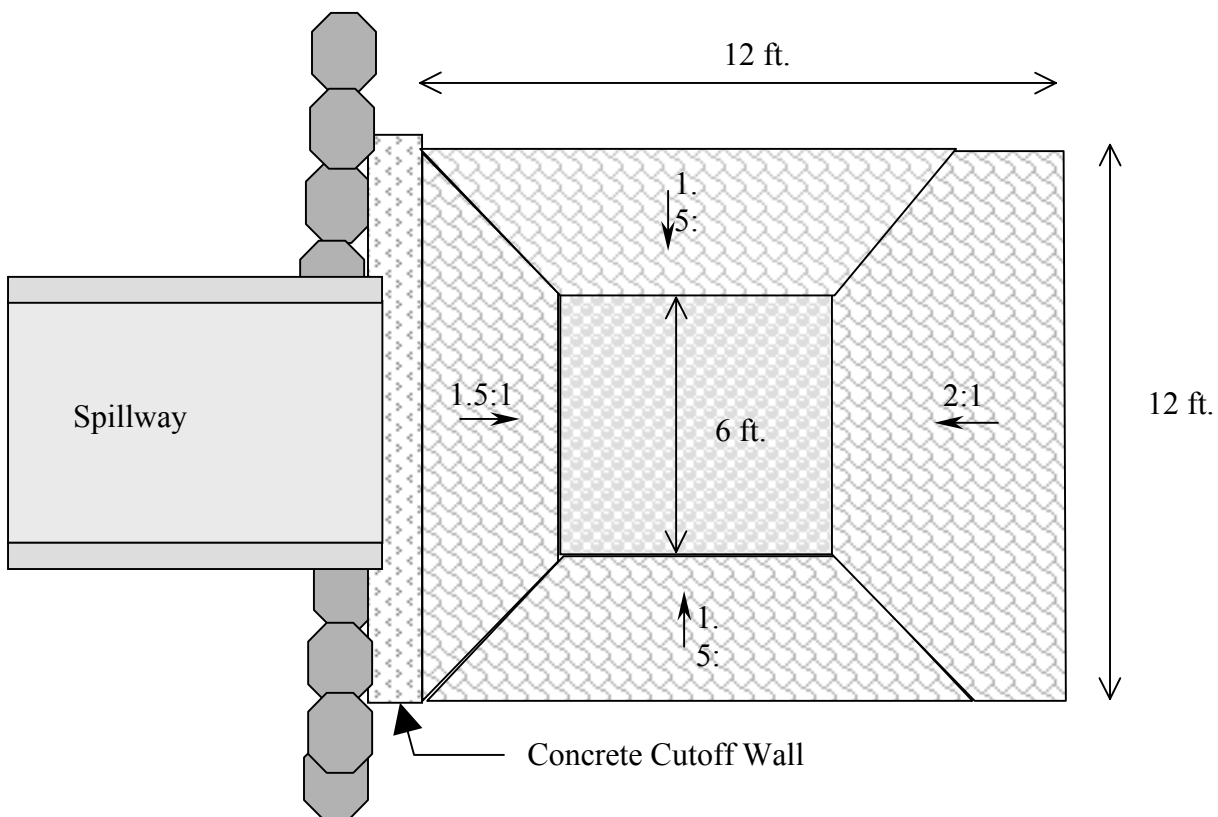
Figure 9 - Stilling Basin Conceptual Plan

Erosion protection on the downstream face consisted of corrugated metal sheets strapped to the rock facing. Under large spillway flows, these sheets would not be sturdy enough to protect the facing. The trough used as an energy dissipator may be adequate for low flows, but would be overwhelmed during floods. Failure of either or both of these elements during a flood could result in severe erosion at the toe and threaten the stability of the dam. Thus, the energy dissipator and slope protection need to be significantly improved.

prevent spillway flows from dislodging the rock. However, the sheeting is flimsy and poorly anchored. Under large spillway flows, the sheeting could break loose and the rock could be dislodged, removing support for the core wall and threatening the stability of the dam. Thus, the sheeting should be replaced with some sort of protection that is sturdier and well-anchored to the slope. One option would be to use heavier steel sheeting supported on wood framing.

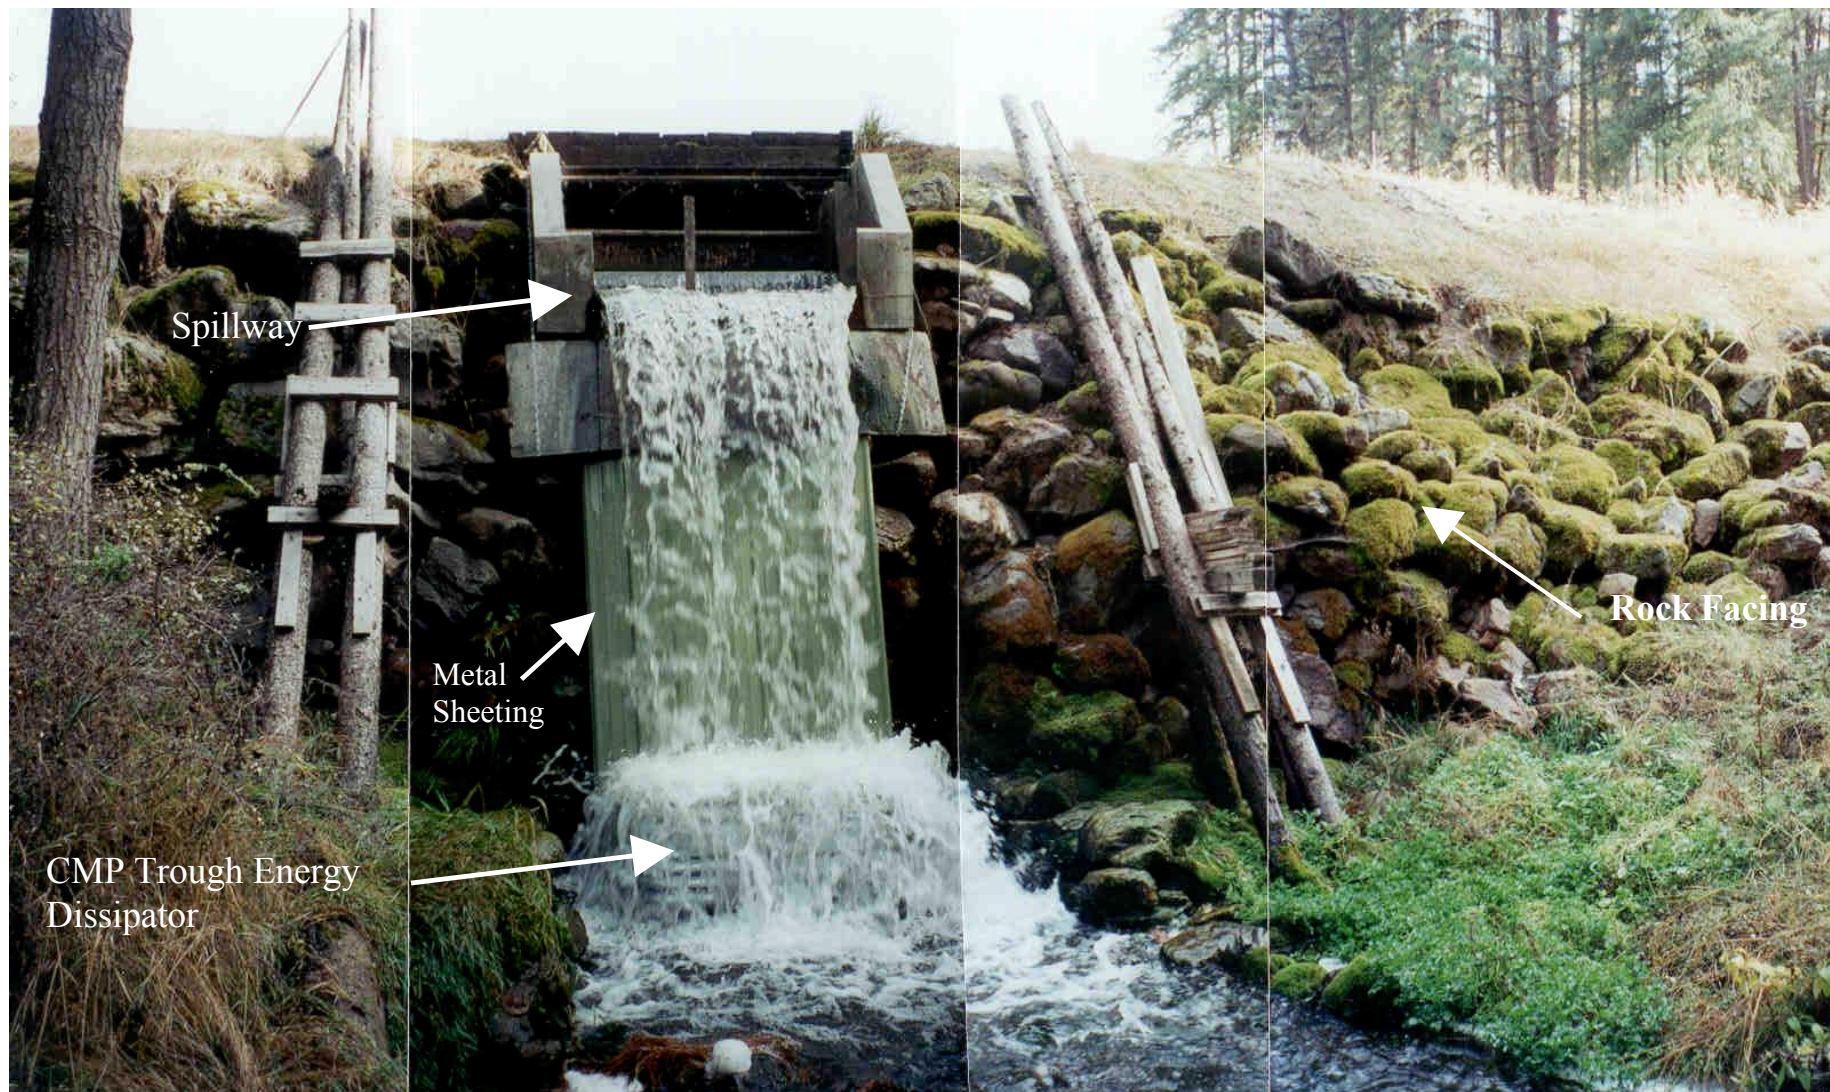
Photo 1: Beitey Lake Dam Downstream Face

An examination of the downstream face of the dam revealed that there was no sign of displacement or movement of the rock facing. According to Mr. Beity, this facing was placed when the dam was constructed in the 1920's, and to his knowledge has never needed repair. No seepage was noted coming from the rock or downstream toe area. However, seepage was noted coming from the left abutment several feet downstream from the toe. The seepage was clear, and the total quantity was on the order of 2 gallons per minute. According to Mr. Beitey, this seepage has been present for as long as he can remember, and has not increased over the years.

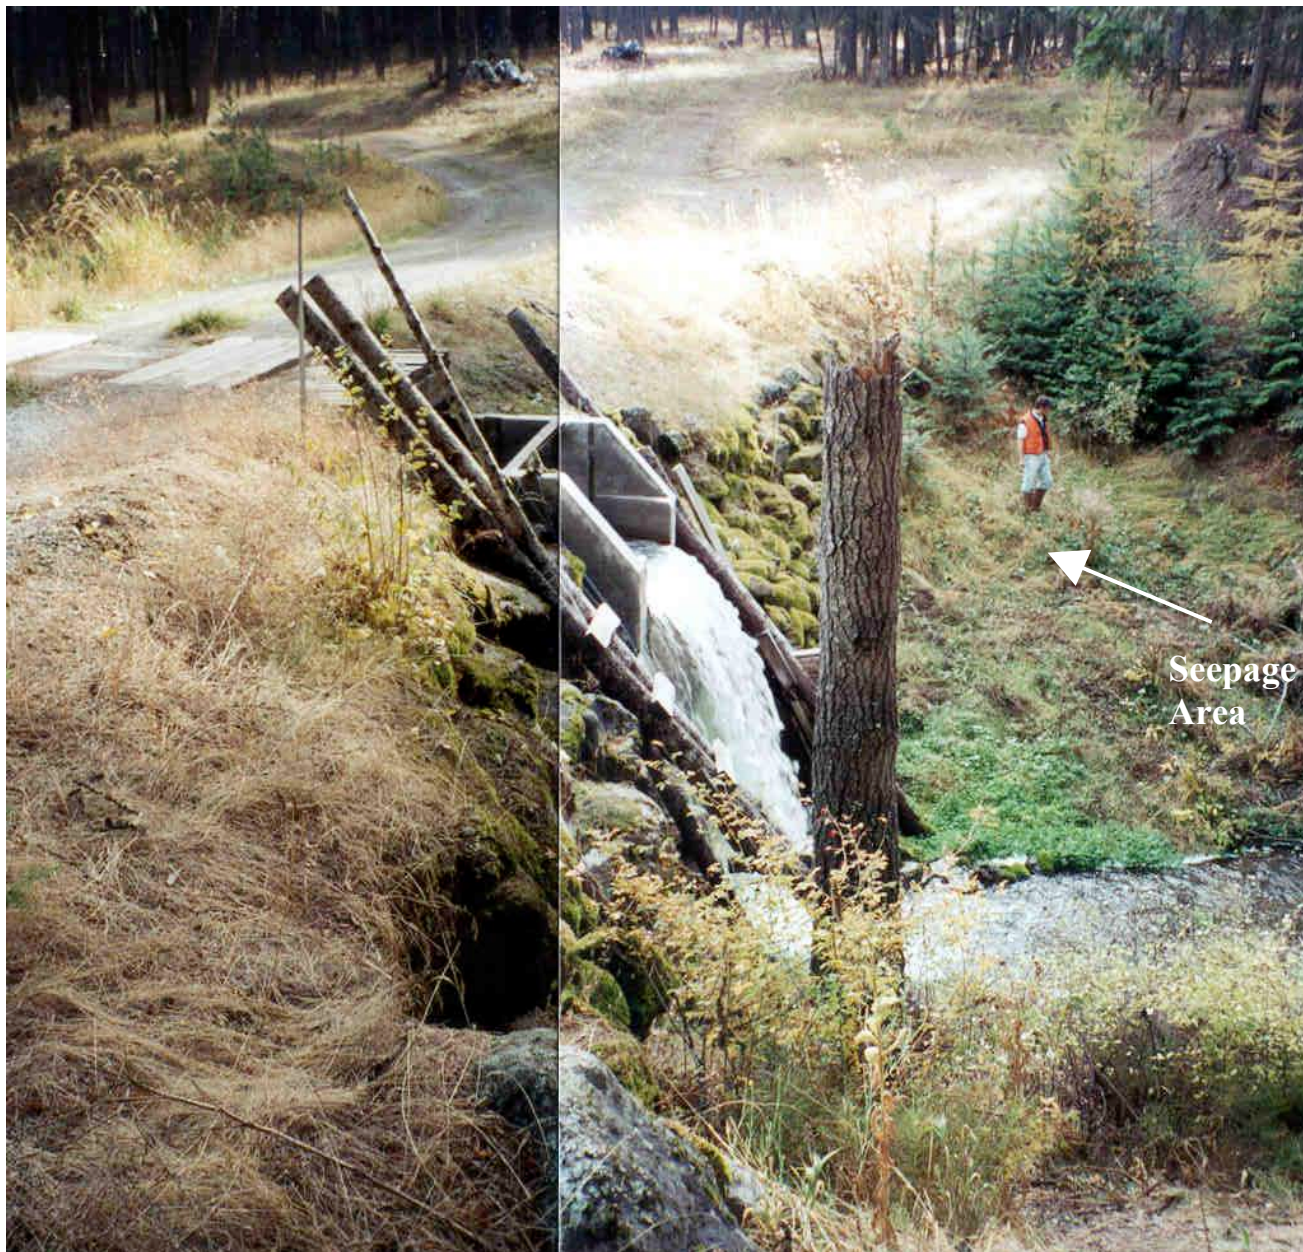
Photo 2: Crest & Downstream Face Looking South

We next examined the dam crest, and discovered no cracks, sinkholes, erosion, or other signs of instability. Our survey of the dam crest did not show any obvious signs of settlement along the crest. According to Mr. Beitey, numerous loaded log trucks have crossed the dam crest over the years and the dam has held up well.

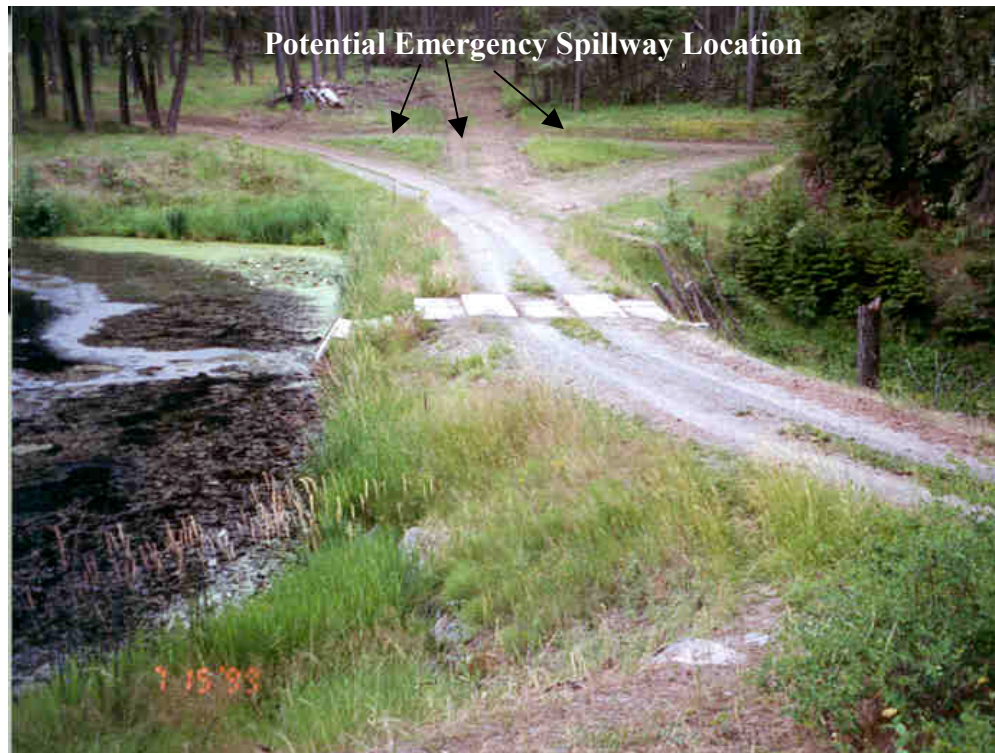
Photo 3: Upstream Face & Dam Crest Looking South

We first inspected the visible portion of the upstream slope above the water line. No signs of cracking, instability or erosion were noted. Although no slope protection is provided, there was no evidence of wave erosion noted at the water line. A growth of grass at the water line appeared to provide adequate protection from erosion.
